TECHNICAL SERVICE BULLETIN

Distribution To: General Distribution
TSB Number: 250501
Date: 01/05/2025
Product Brand: Narva
Product Category: LED Lighting

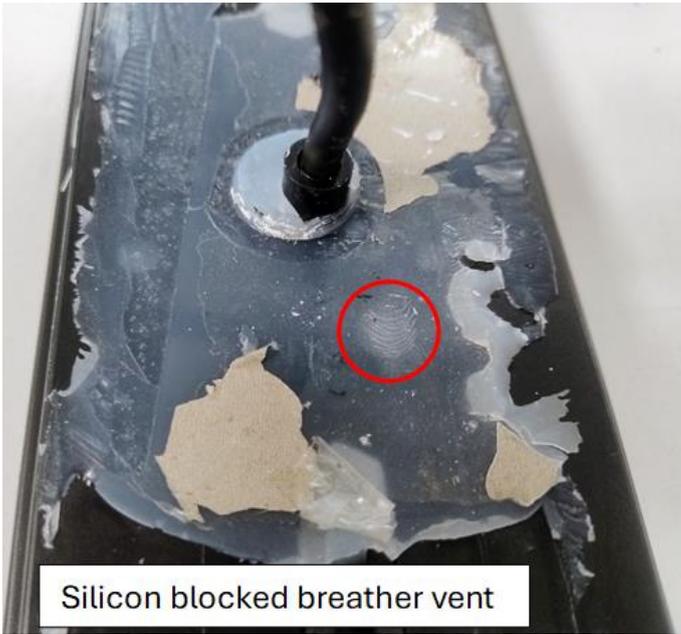
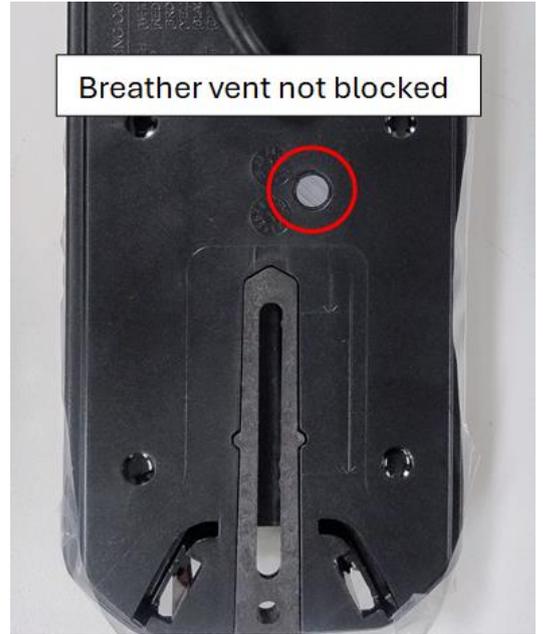
There's potential of the tail lamps having condensation/water ingress if the breather vent is blocked.

Investigation on the lamps with water ingress showed that the breather vent at the back of lamp was blocked with silicon during fitment onto the flat panel surface of vehicle.

The purpose of the breather vent is to allow moisture going in/out of the lamp. If it's blocked, condensation will build up.

Ensure that the breather vent is not blocked or sealed during fitment.
