TECHNICAL SERVICE BULLETIN

Distribution To: General Distribution
TSB Number: 250501
Date: 01/05/2025
Product Brand: Narva
Product Category: LED Lighting

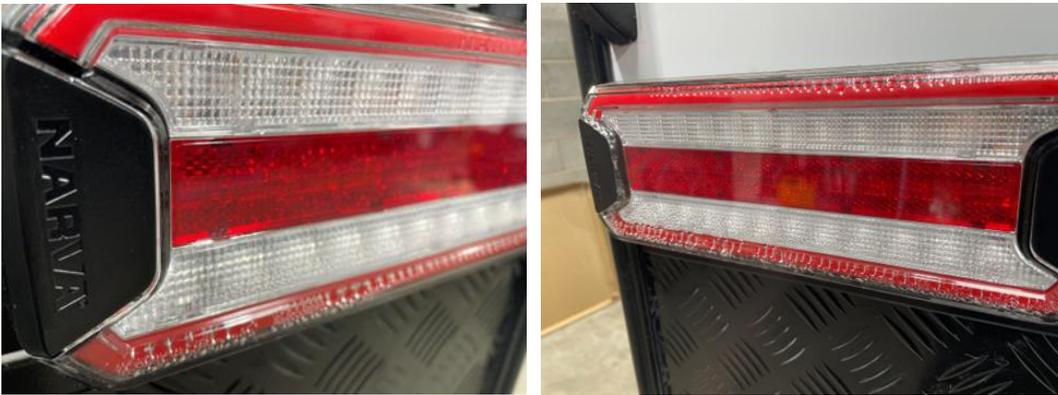
There's potential of the tail lamps having condensation/water ingress if the breather vent is blocked.

Investigation on the lamps with water ingress showed that the breather vent at the back of lamp was blocked with silicon during fitment onto the flat panel surface of vehicle.

The purpose of the breather vent is to allow moisture going in/out of the lamp. If it's blocked, condensation will build up.

Ensure that the breather vent is not blocked or sealed during fitment.
